Manhole Inspection Summary

Manhole # S19KK_005MH

Insp Date: **6/4/07 8:04 AM**

Location Address: **2100 CLIFTON AVE**

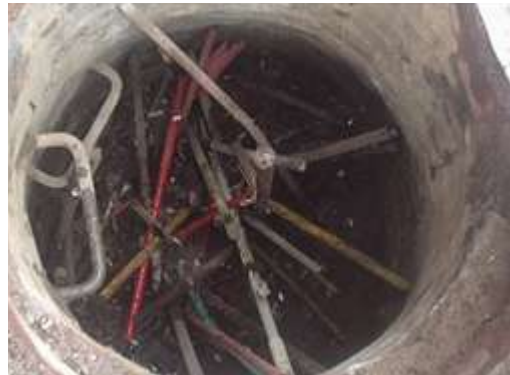
Top View

Comments **alot of debris in mh**

A LOT OF DEBRIS IN MH

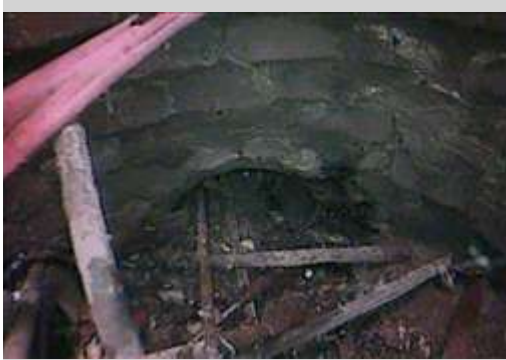
Defect 3

Condition: ☐ Sound ☐ Cracked ☐ Root Intrusion ☐ Deteriorated ☐ Leaks ☒ **Debris**

DEBRIS IN CHANNEL

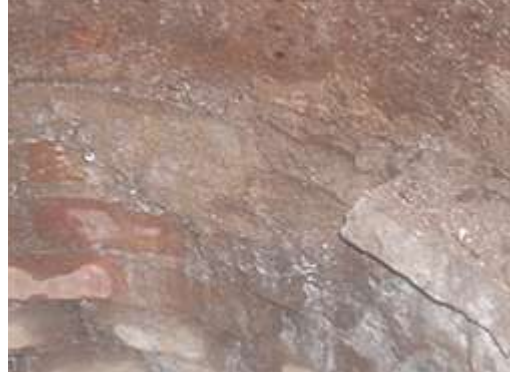
Defect 2

Condition: ☐ Sound ☐ Cracked ☐ Root Intrusion ☐ Loose Brick ☒ **Deteriorated**

DETERIORATION OF CHIMNEY

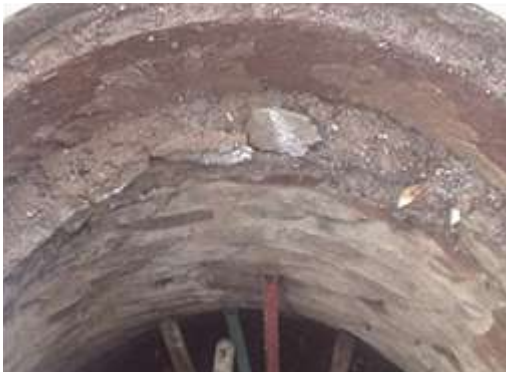
Defect 1

Offset: **2** (in.)

FRAME OFFSET

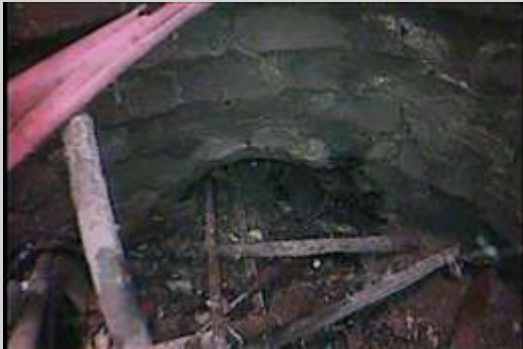
12 O'Clock Outflow

Deposits: ☐ None ☐ Mud ☐ Sludge ☒ **Debris** ☐ Grease

Silt Depth: **6** (in.) Deposits Extent: **Medium**
